Chagrin State Scenic River

Stream Quality Monitoring

2007 Annual Report

Chagrin State Scenic River 2007 Stream Quality Monitoring Annual Report

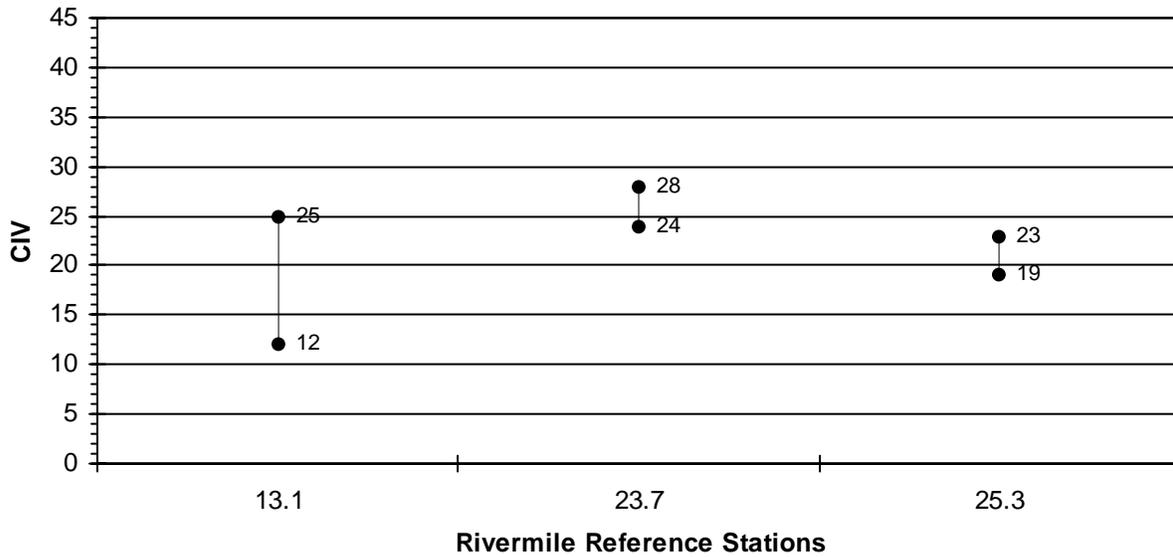
Figure 1.1 Chagrin River CIV Max and Min Ranges 2007

Figures 1.1 and 2.1 represent the maximum and minimum range of CIV recorded during the year for each reference station. Figures 1.2 and 2.2 represent mean CIV at each reference station over many years.
