Ohio
Stream Quality Monitoring
2008 Annual Report

Chagrin State Scenic River 2008 Stream Quality Monitoring Annual Report

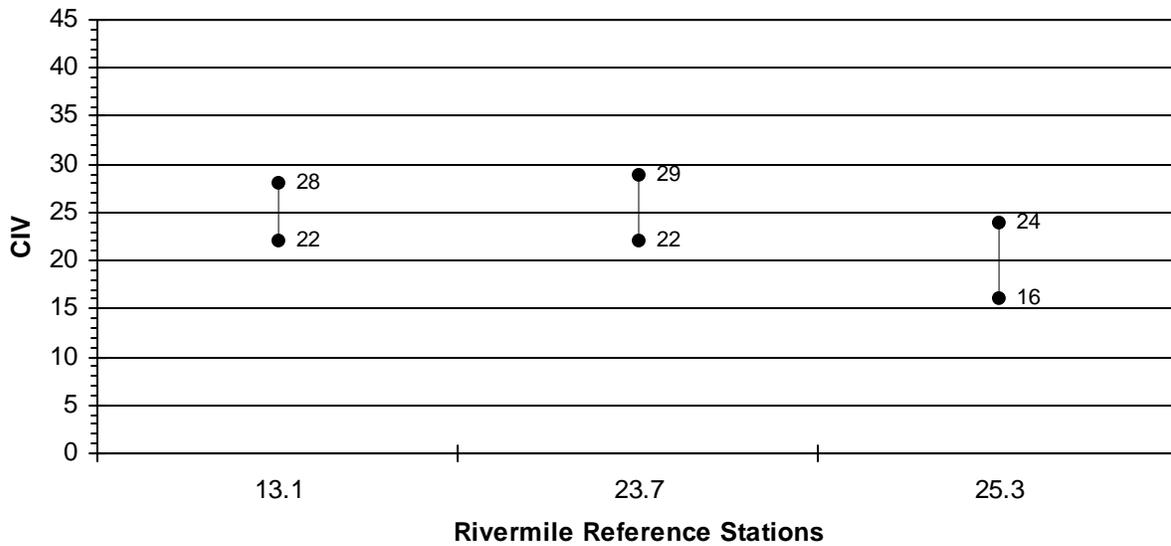
Figure 1.1 Chagrin River CIV Max and Min Ranges 2008

Figures 1.1 and 2.1 represent the maximum and minimum range of CIV recorded during the year for each reference station. Figures 1.2 and 2.2 represent mean CIV at each reference station over many years.
