# Stillwater/ Greenville Creek State Scenic River

Ohio  
Stream Quality Monitoring  
2008 Annual Report

# Stillwater/Greenville State Scenic River 2008 Stream Quality Monitoring Annual Report

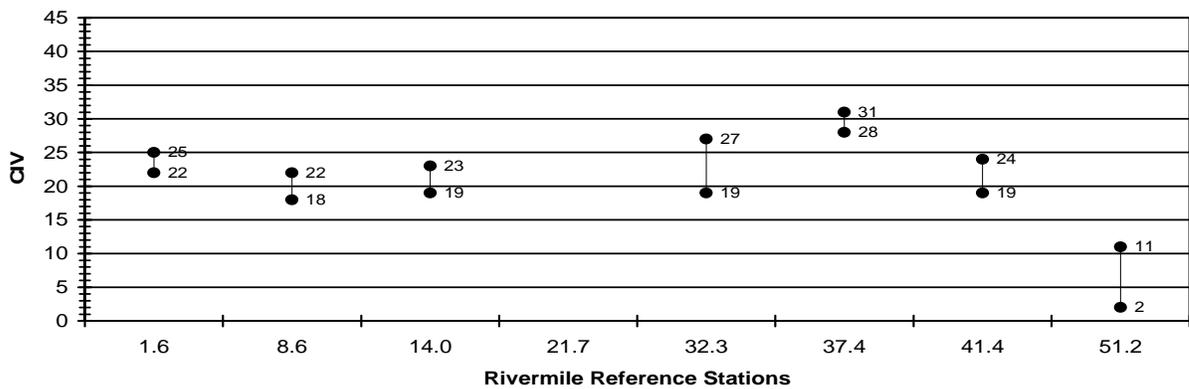
**Figure 1.1 Stillwater River CIV Max and Min Ranges 2008**

Figure 1.1 and 2.1 represents the maximum and minimum CIV range recorded during the year for each reference station. Figure 1.2 and 2.2 represents mean CIV at each reference station over many years.

CIVs on three Stillwater River stations increased during the 2008 season while four decreased. The individuals of Group 1 taxa on all sites remained the same, while there was a slight decrease in the individuals of both the Group 2 and Group 3 taxa. The 2008 season's 21.2 CIV averages on the Stillwater River are down compared to 2007 season's averages of 24.4 CIV. The 2008 average corresponds to the good range, which is a significant change from the previous year's excellent score. Although the score dropped a category, the results still fall with the EPA guidelines for Warm Water Habitat. Scenic River staff will continue to monitor these areas closely during 2009. The Stillwater River average taxonomic diversity per assessment was nine macroinvertebrate orders (e.g. stonefly, damselfly, mayfly, etc.).
