Stream Quality Monitoring 2010 Annual Report

Sandusky State Scenic River

Ohio Department of Natural Resources
Division of Watercraft

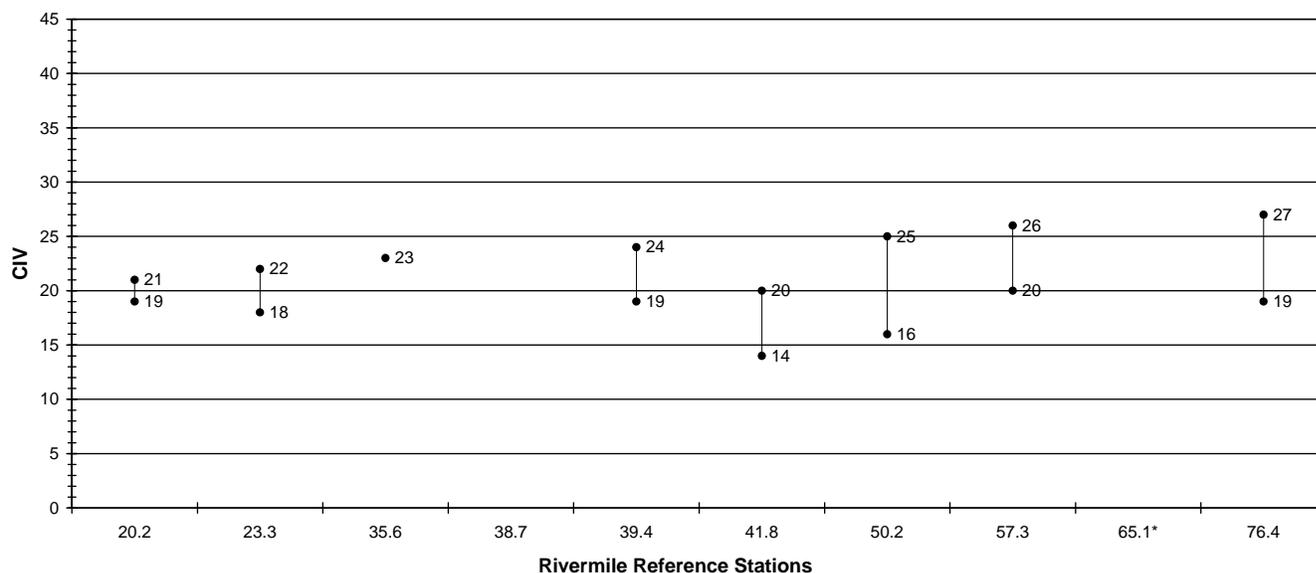
Figure 1. Sandusky River 2010 CIV Maximum & Minimum Ranges

Figure 1 represents the maximum and minimum range of CIVs recorded during the year for each reference station. Figure 2 represents mean CIVs at each reference station over many years.
